Land Management Plan

A Narrative for Invasive Plant Management
and Native Plant Restoration

66 Burditt Ave
Hingham, MA

Summer 2020

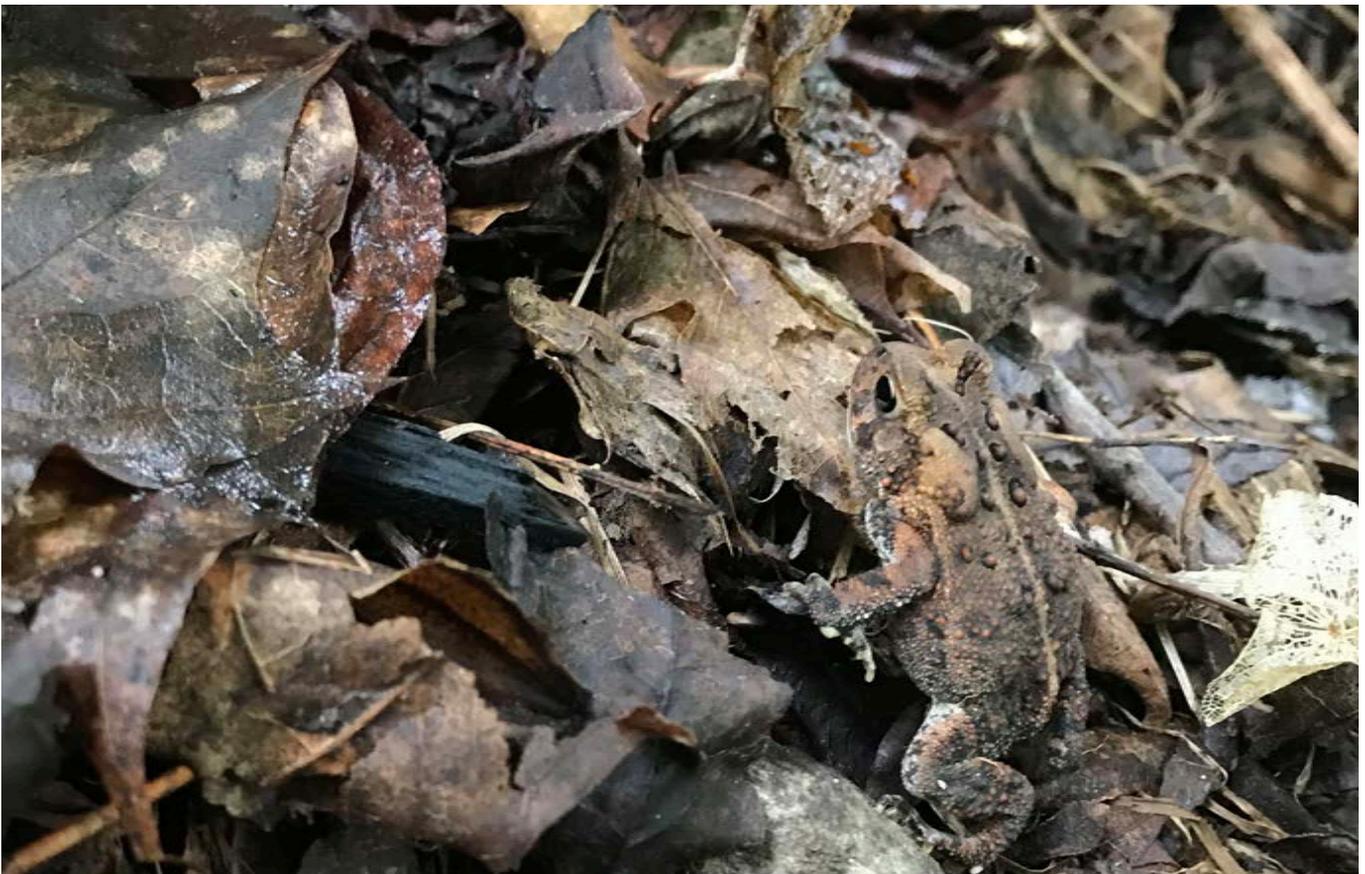
A Fowlers Toad (*Anaxyrus fowleri*) clings ton the slope of the bank. The Land Management Plan proposes offsetting landscape enhancement construction by controlling/eliminating invasive species populations and restoring some areas with native plant species that will further support wildlife along the Cove.

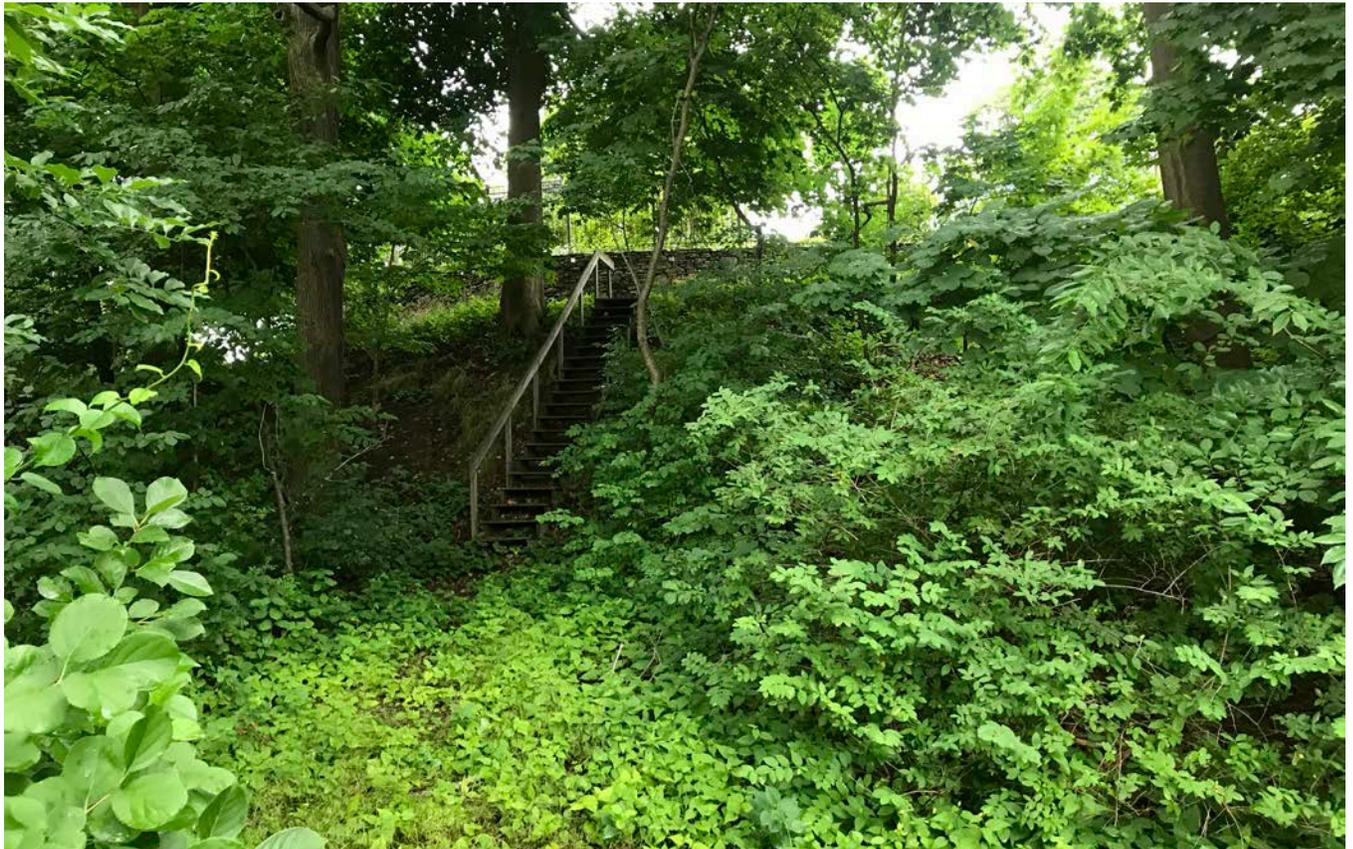
● Along the stairway are three large Norway Maples on the slope and a dense pocket of Morrow's Honeysuckle, Glossy Buckthorn, and Bittersweet. East of the stairway, dense shade restricts growth of vegetation and erosion is visible

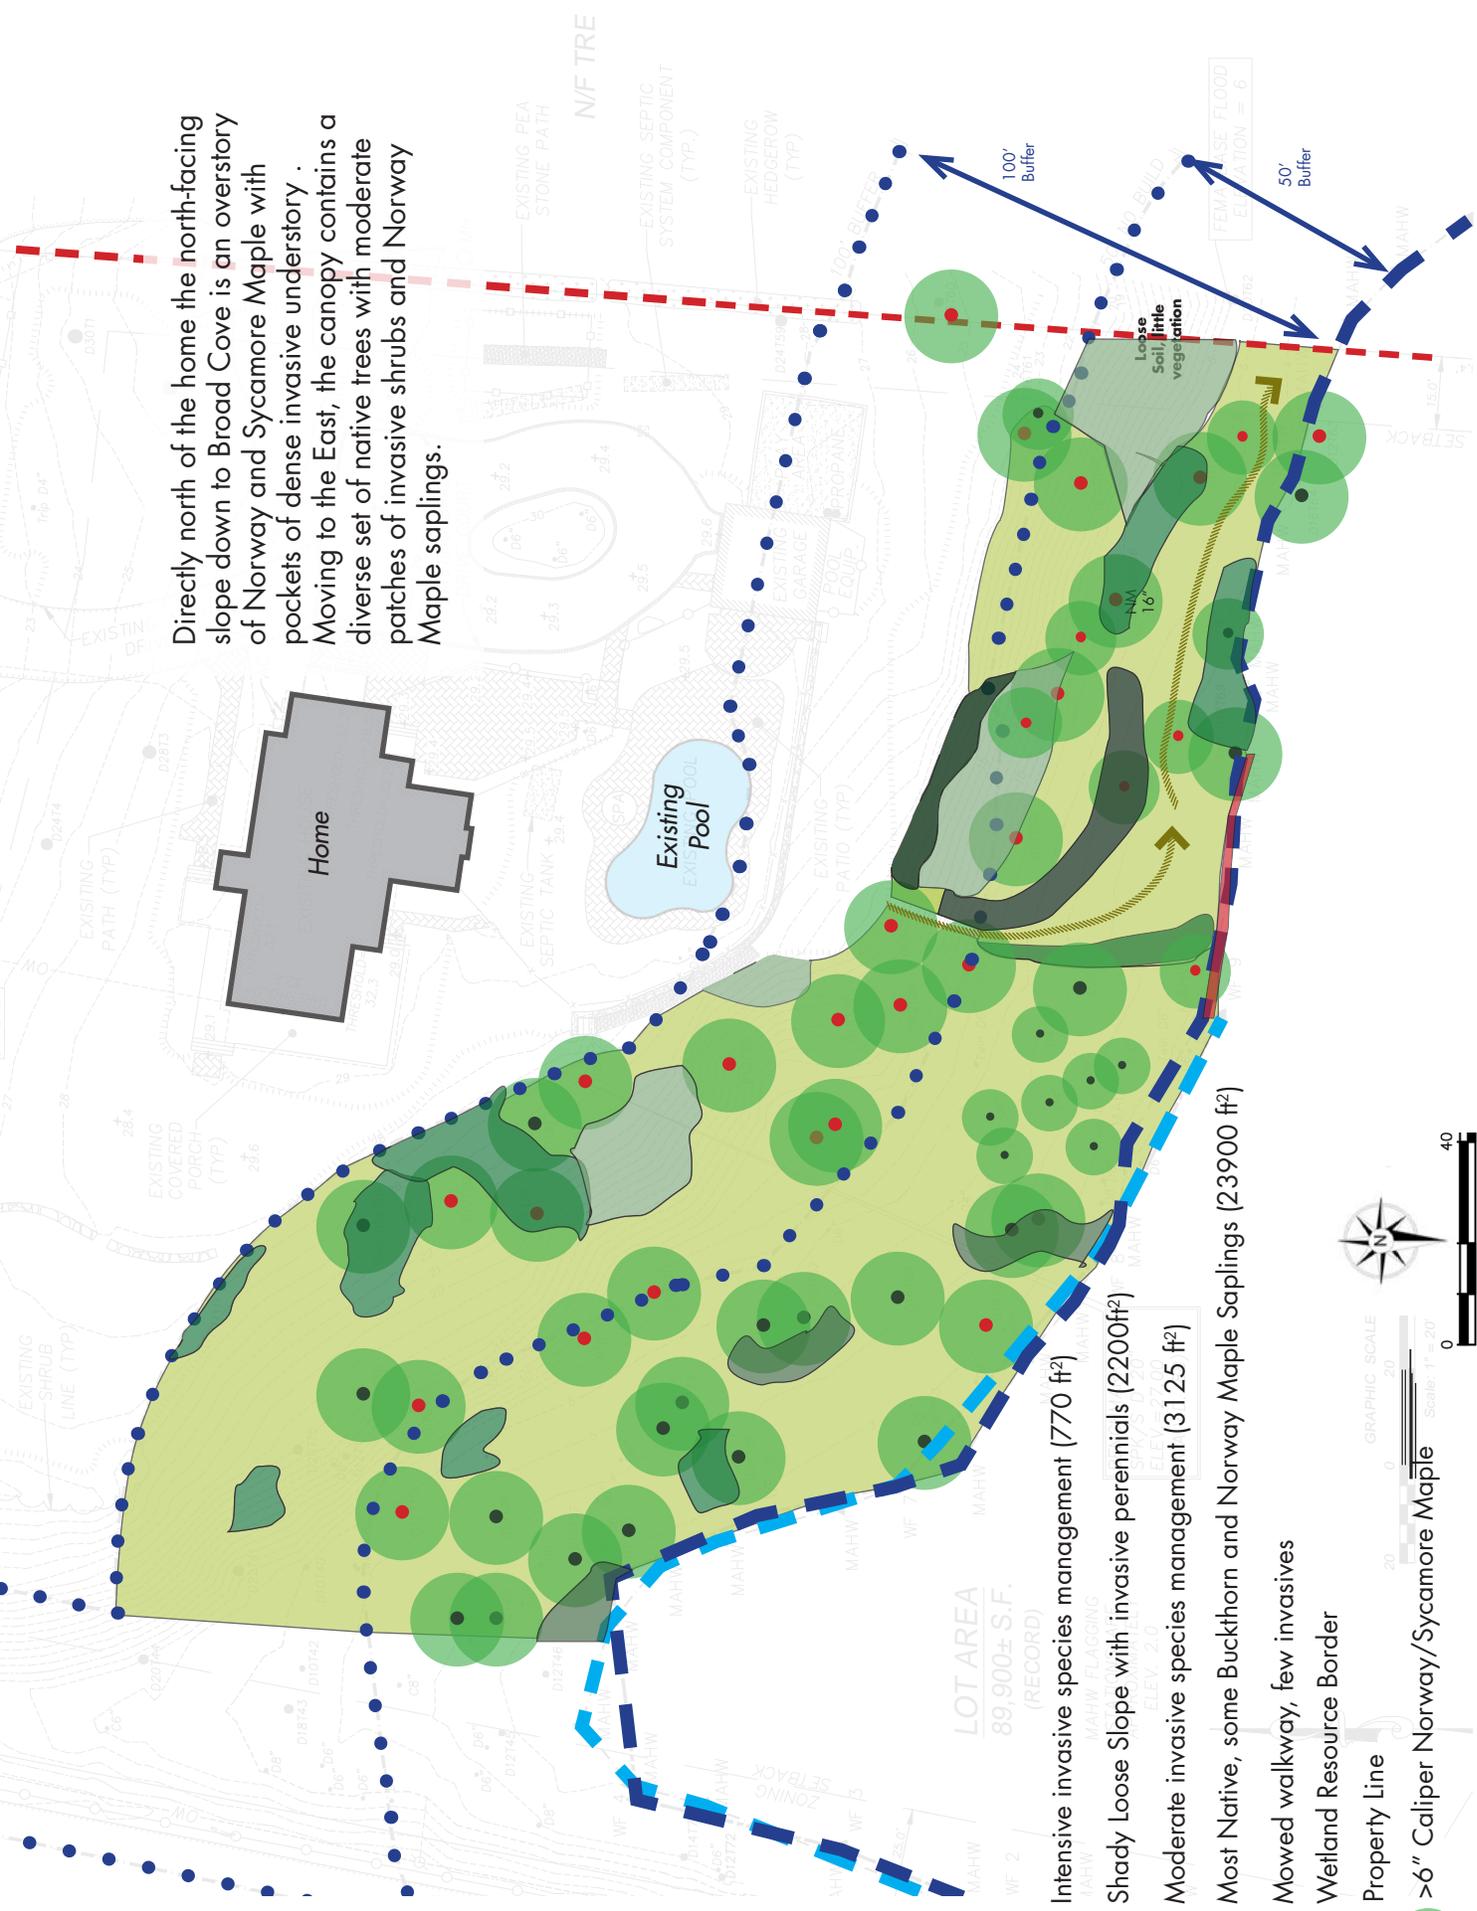
- Intensive invasive species management (770 ft²)
- Shady Loose Slope with invasive perennials (2200ft²)
- Moderate invasive species management (3125 ft²)
- Most Native, some Buckhorn and Norway Maple Saplings (23900 ft²)
- Mowed walkway, few invasives
- Wetland Resource Border
- Property Line
- >6" Caliper Norway/Sycamore Maple

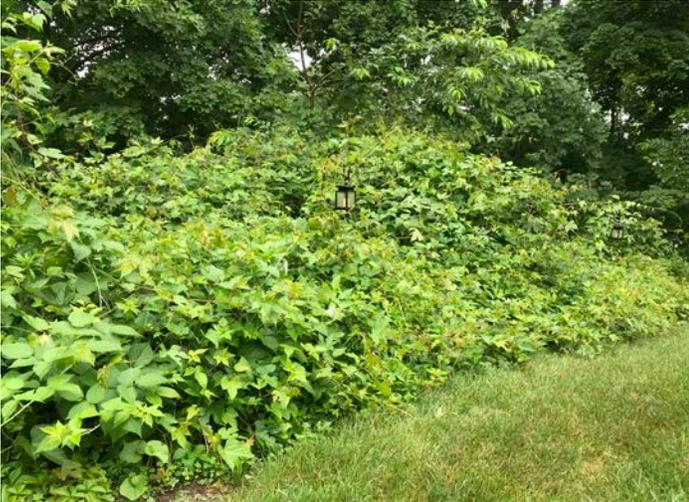
A dense stand of Porcelain Berry at the top of the slope shades out previous plantings and threatens native understory

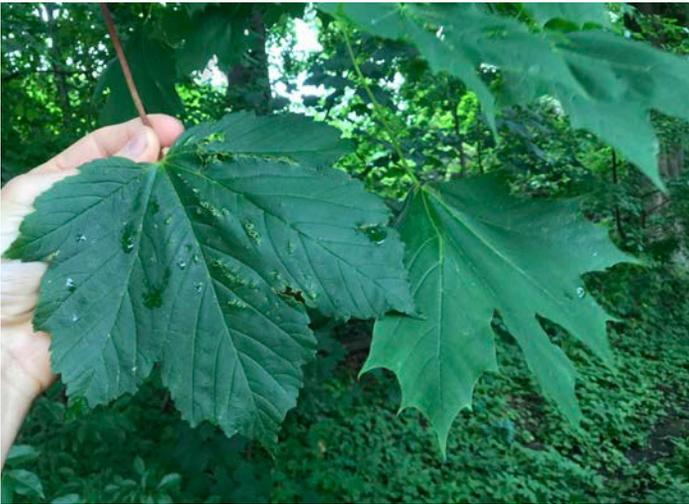
Sycamore Maple (left) next to a Norway Maple along the bank

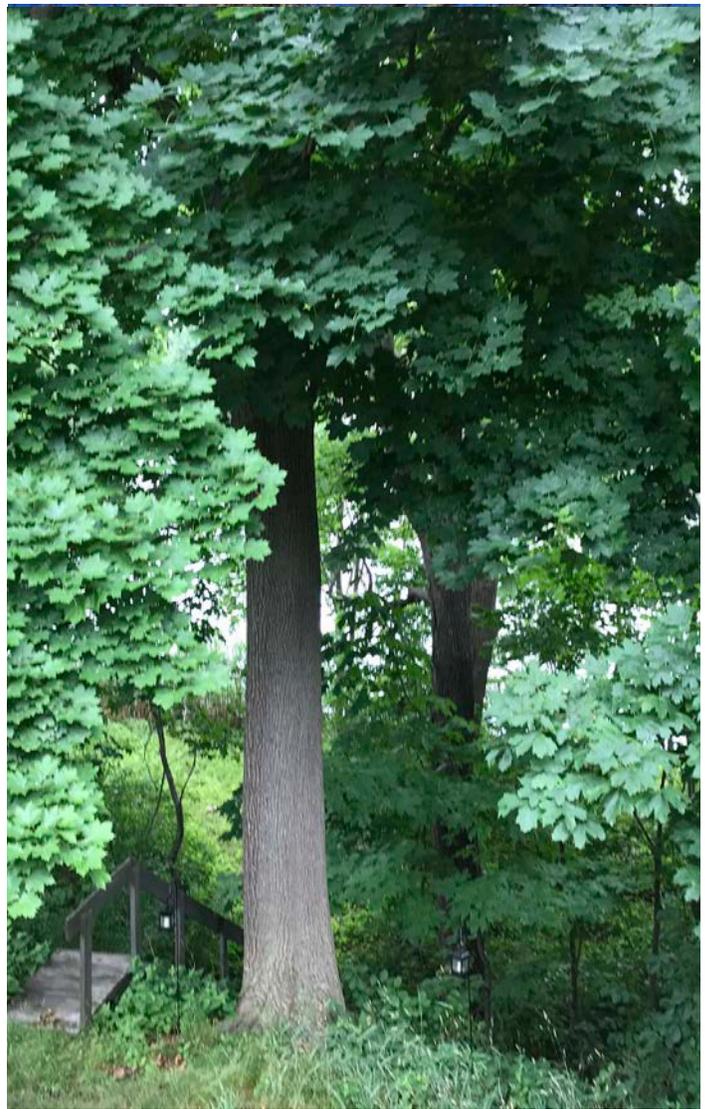
Norway Maples casting dense shade on the North-facing slope

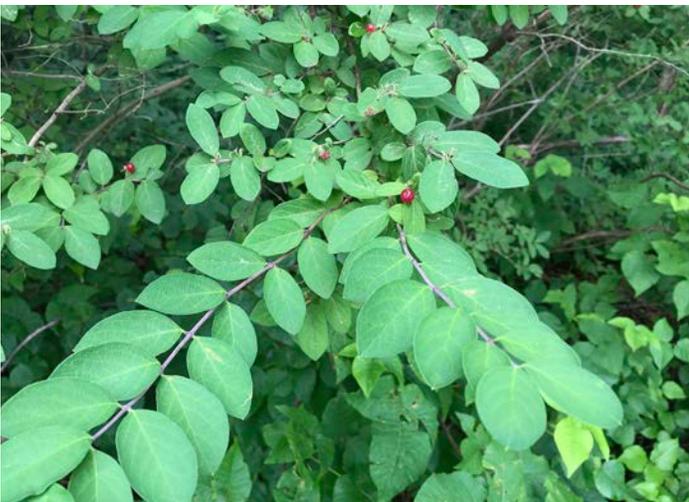
Morrow's Honeysuckle in fruit along the slope Northeast of the home

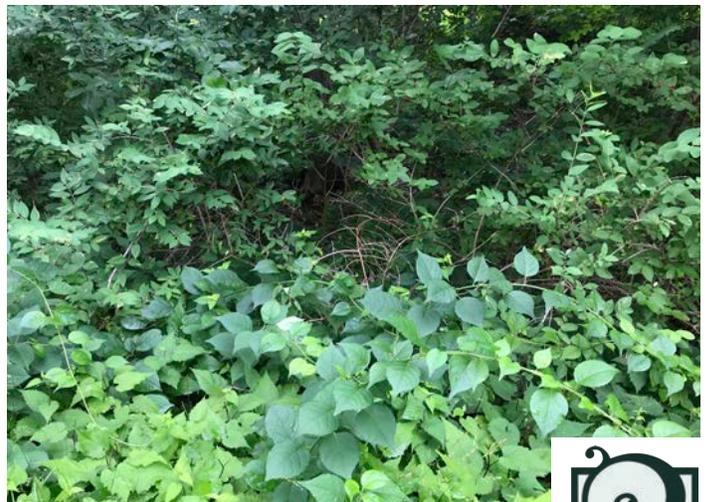
Bittersweet vines entangled in a Morrow's Honeysuckle can be damaging to mature trees if left unchecked

Removing the entire vines from trees is often dangerous and unnecessary (unless it poses safety risk). Our team recommends making cuts at shoulder height followed by a cut at 12" and immediate herbicide treatment. Bittersweet aggressively suckers after cutting so it is important to cut and treat during or after its flowering period (late June to December).

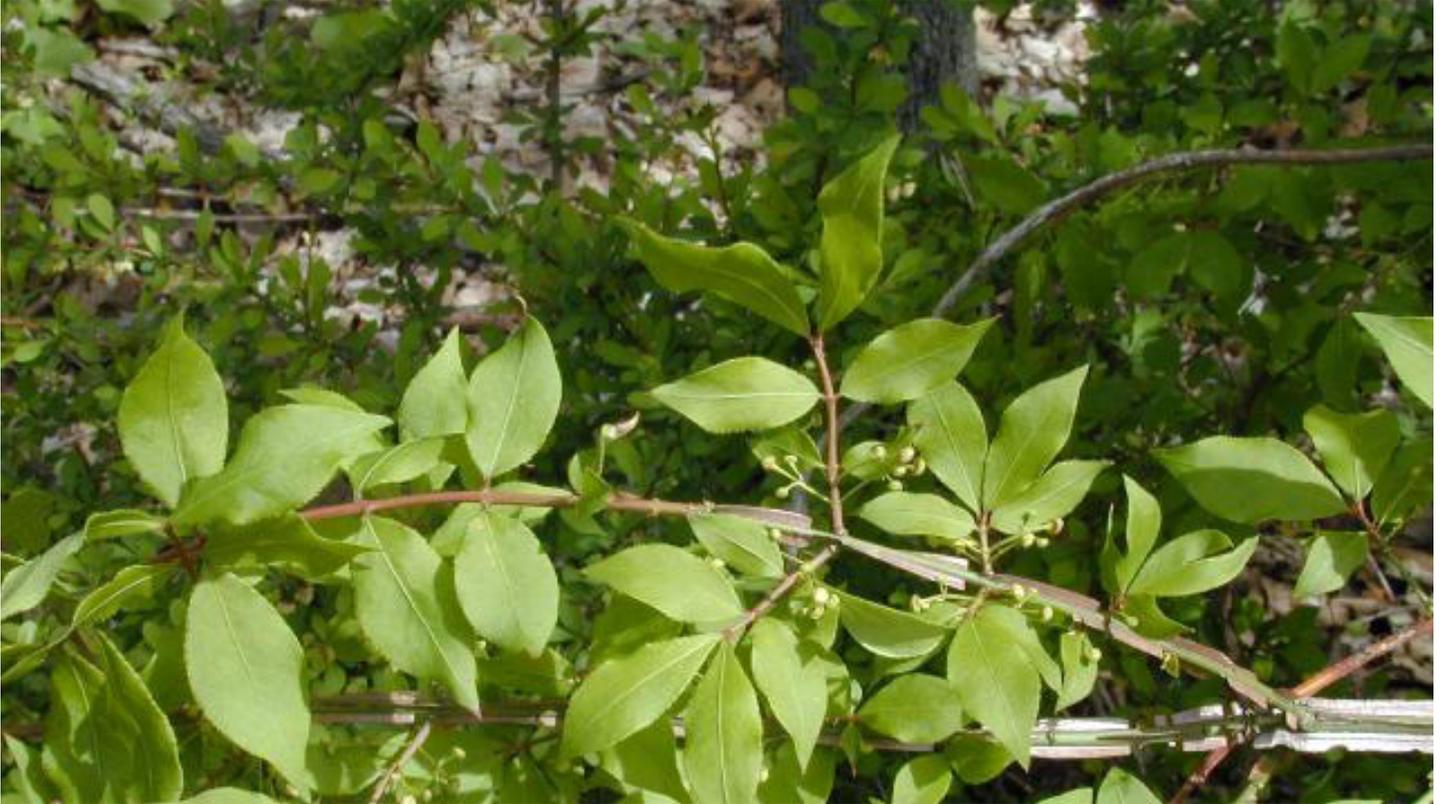
Burning Bush, *Evonymus alatus*, was historically planted along the edge of the lawn and has begun seeding itself into the woodland understory.

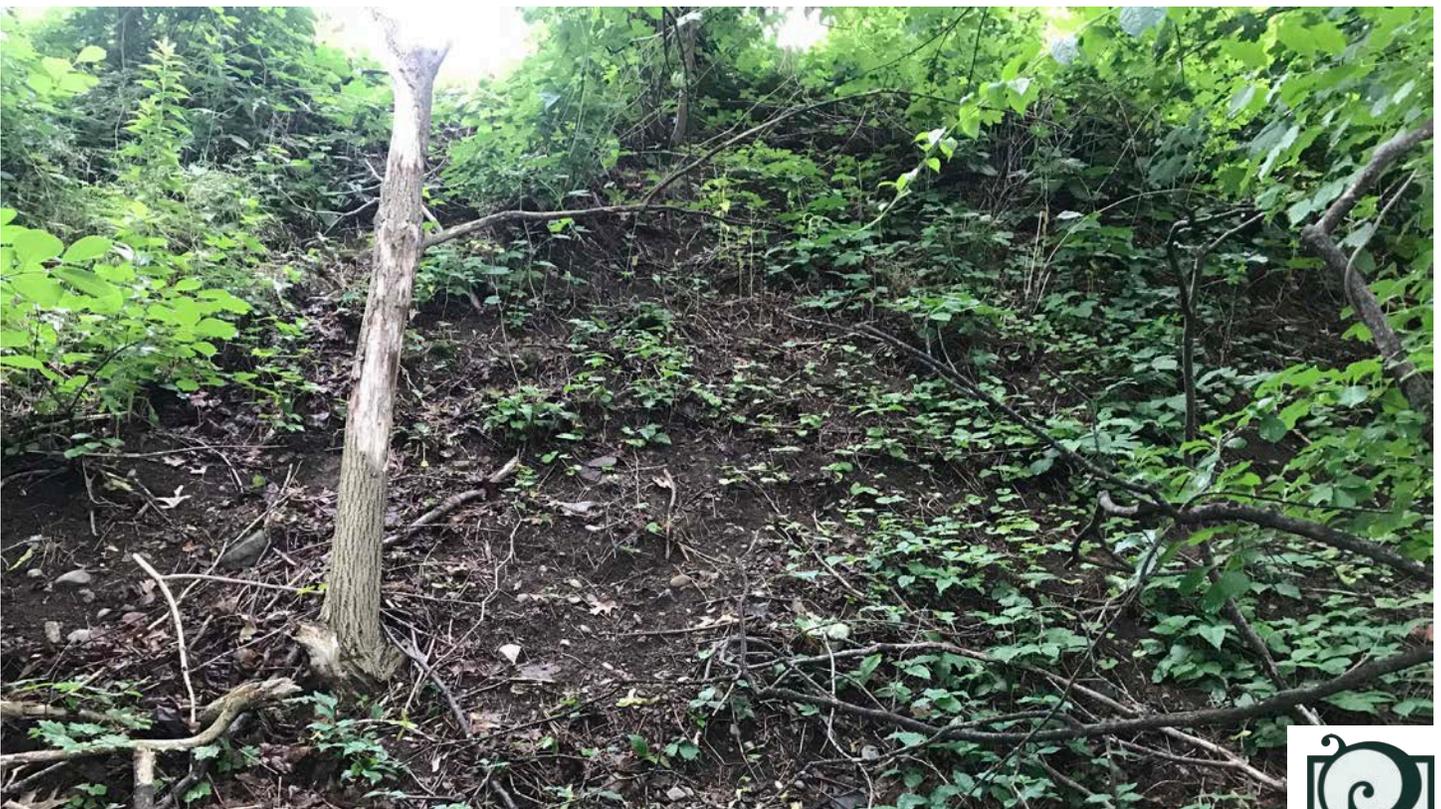
Dense shade caused by Norway Maples on the north-facing slope has led to little native vegetative growth on the slope and subsequent washouts. Cutting and treating the stems of invasives along the slope and replanting native shrubs can stabilize the slope

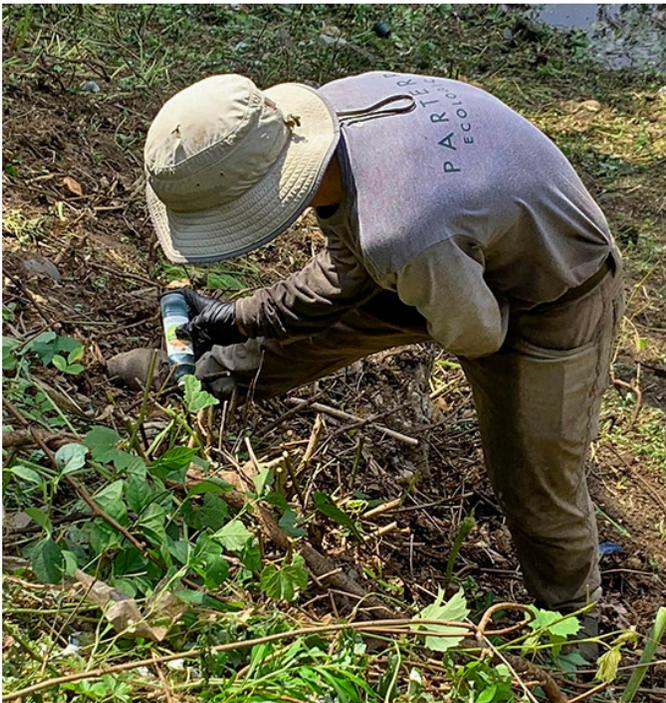
Qualified applicators with necessary Personal Protective Equipment paint the stems of invasive species after cutting

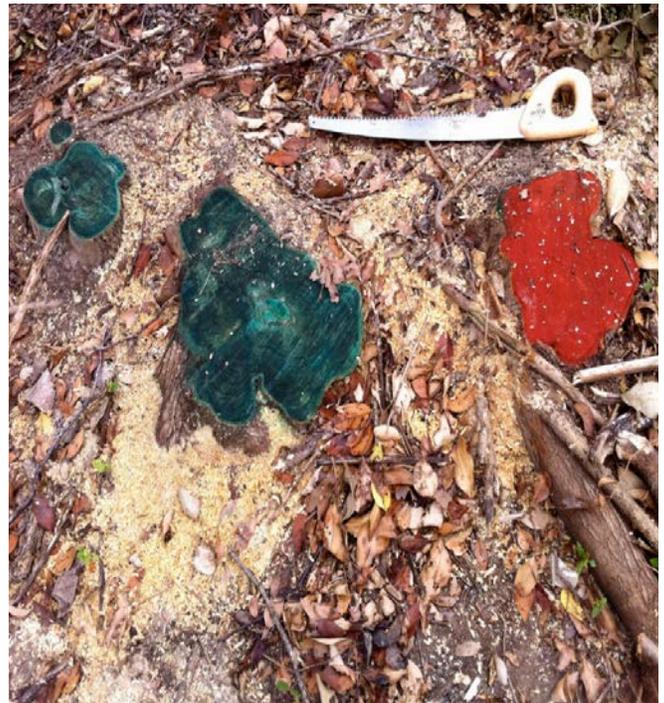
Proposed cut stump treatment using hand tools and applying marking dye to eliminate possibility of treatment of stump twice, or missing stump entirely

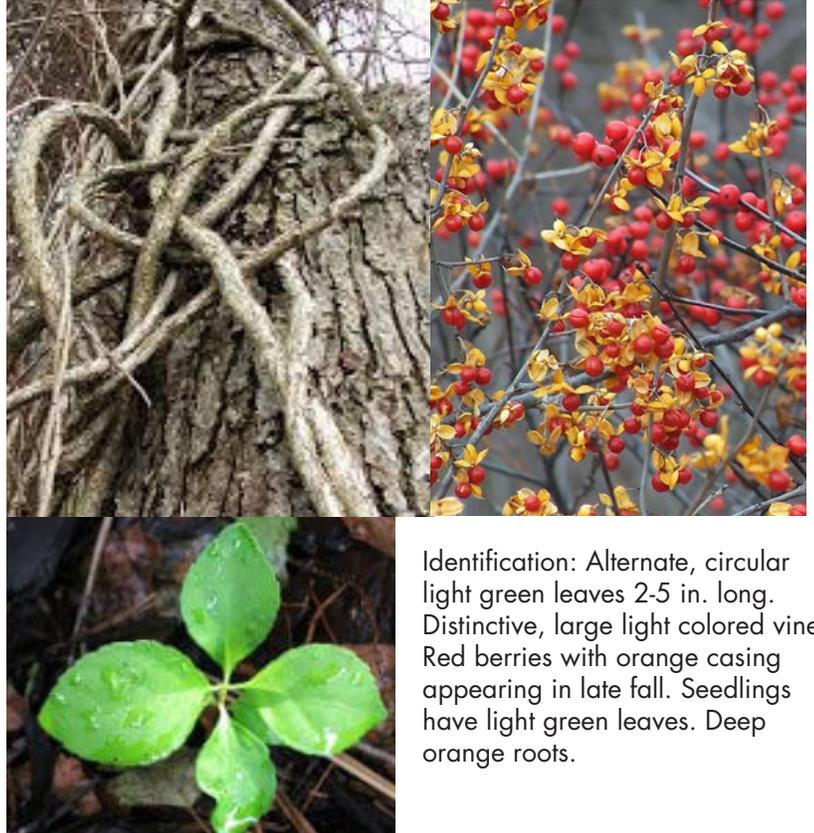
Identification: Alternate, circular light green leaves 2-5 in. long. Distinctive, large light colored vine. Red berries with orange casing appearing in late fall. Seedlings have light green leaves. Deep orange roots.

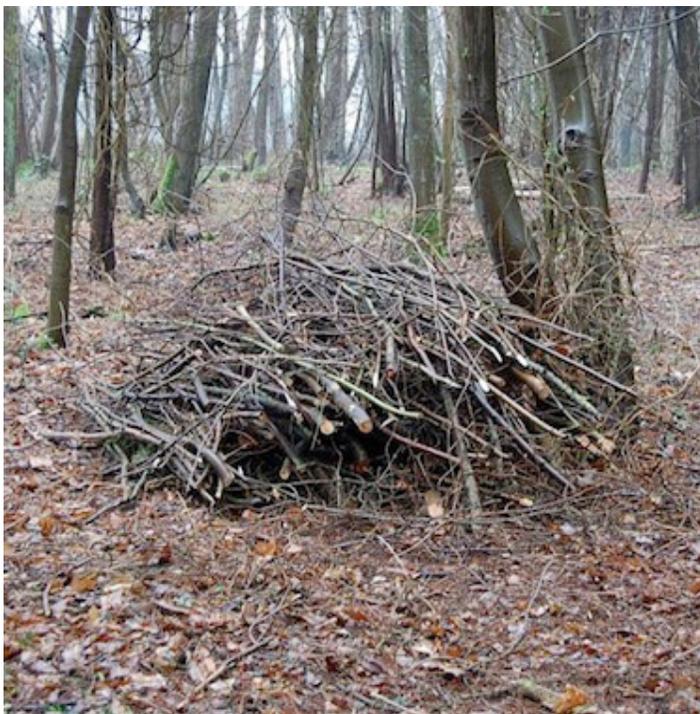
A "Critter Condo" reduces disposal energy while supporting shelter and food for wildlife

- Invasive trees to be removed can be cut to 12-20' above the ground to make them a safe, standing snag.
- Stacked invasive Buckthorn, Honeysuckle, Norway Maple and Sycamore Maple mimic the benefits of down logs and significantly increase shelter opportunities in areas where invasive species are being removed. Additionally, they limit removal of material off site, making the work more efficient and less energy intensive. These "Critter Condos" should be built 10-12 ft. across and 6' tall with larger branches on the bottom and taller on top. Ideally there are at least 2-3 piles per acre.

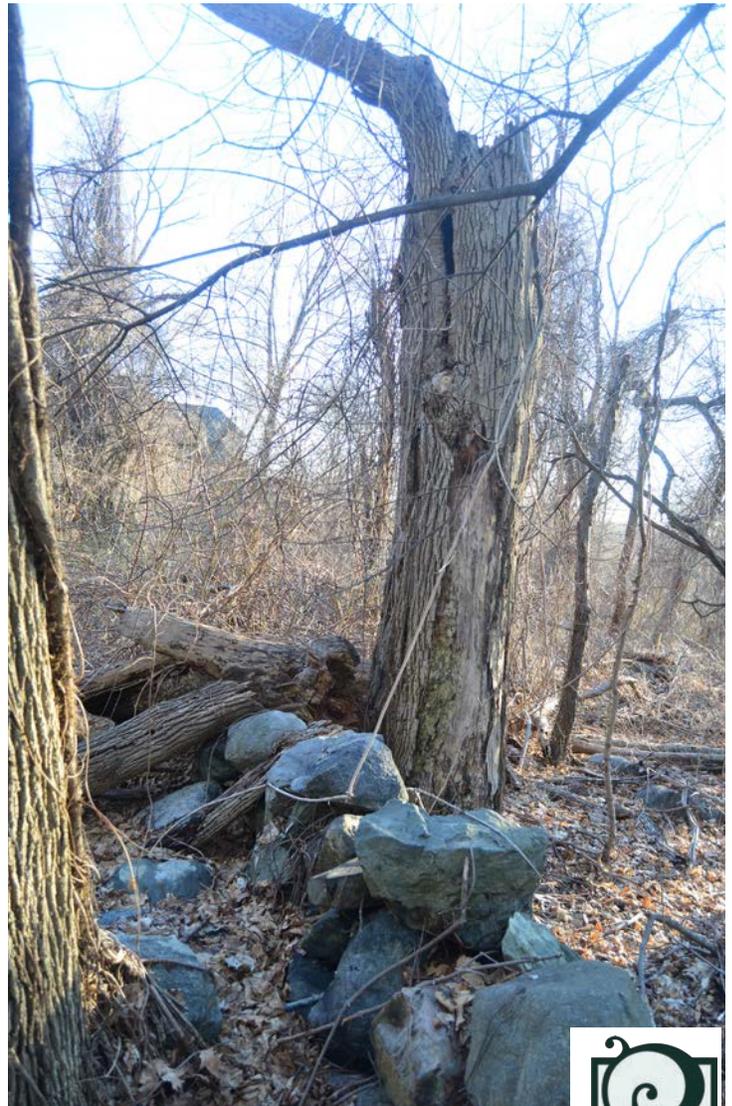
A large dead Sugar Maple houses a woodpecker

- When possible, dead trees and snags should be left standing in the natural area as long as they are not a safety risk. Special consideration should be given to trees greater than 25 inches in diameter which will support woodpecker cavities.

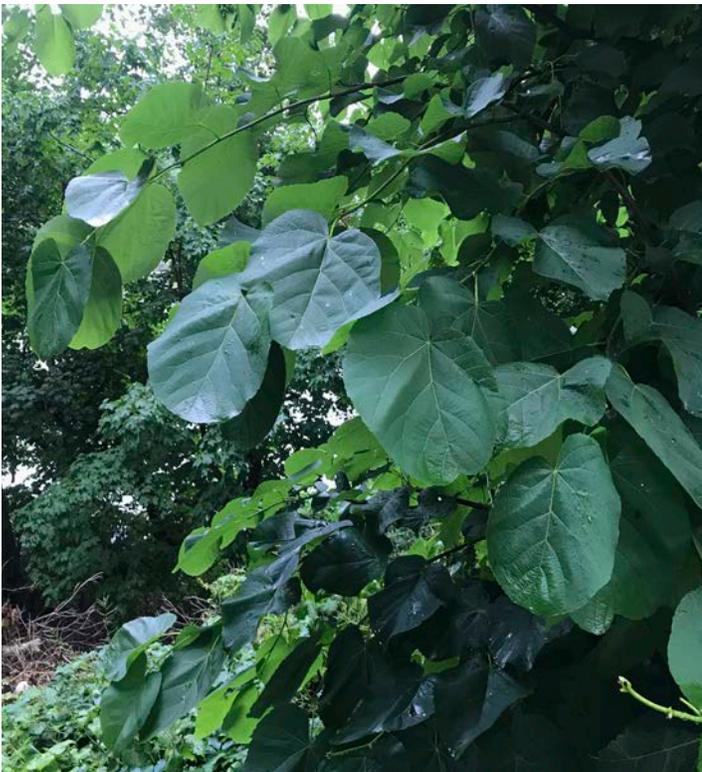
A Basswood Sapling along the water's edge. If permitted these can rise to a canopy tree with a deep taproot that supports the slope. The tree attracts a host of native bees, wasps and caterpillars that support bird populations

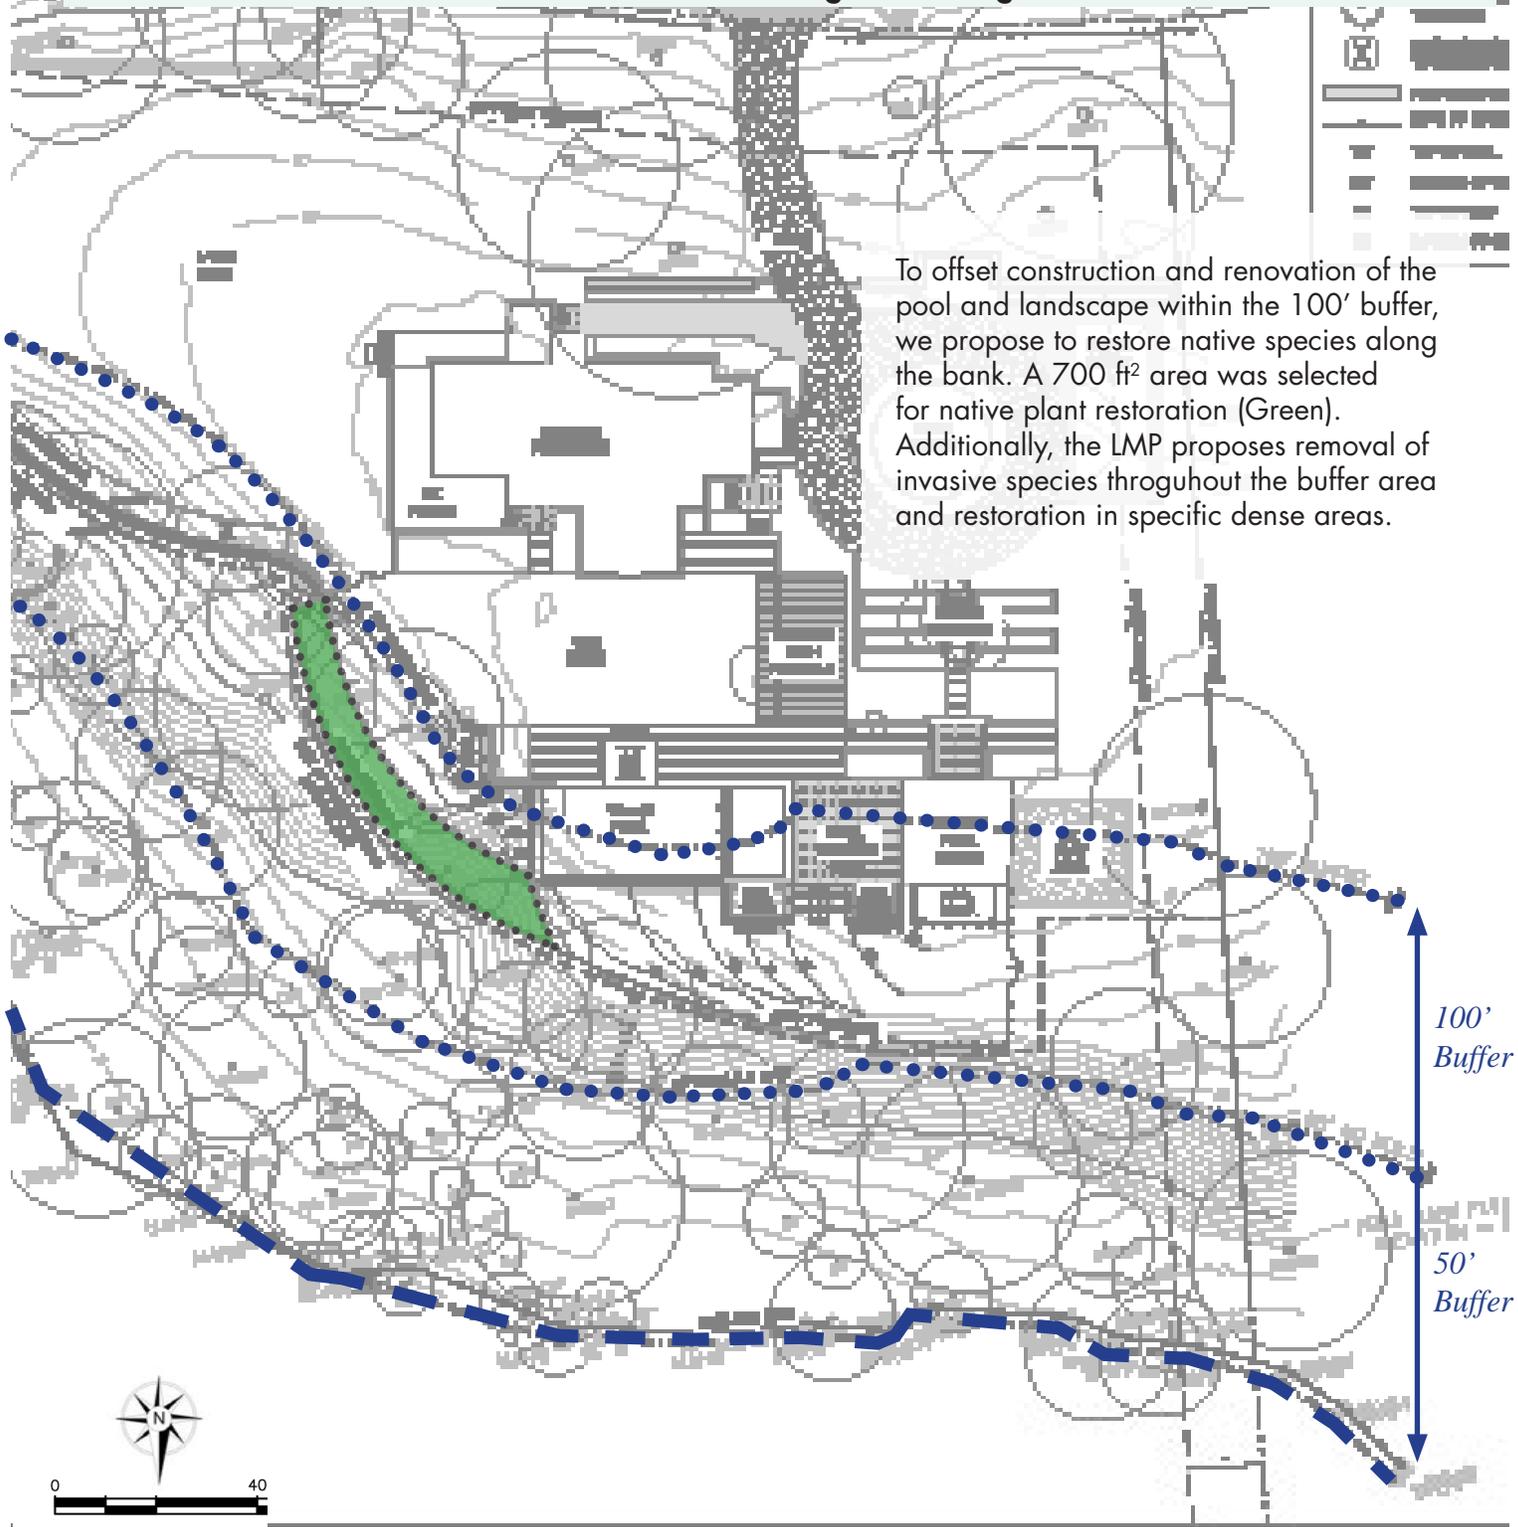
1:1 Mitigation Area

To offset construction and renovation of the pool and landscape within the 100' buffer, we propose to restore native species along the bank. A 700 ft² area was selected for native plant restoration (Green). Additionally, the LMP proposes removal of invasive species throughout the buffer area and restoration in specific dense areas.

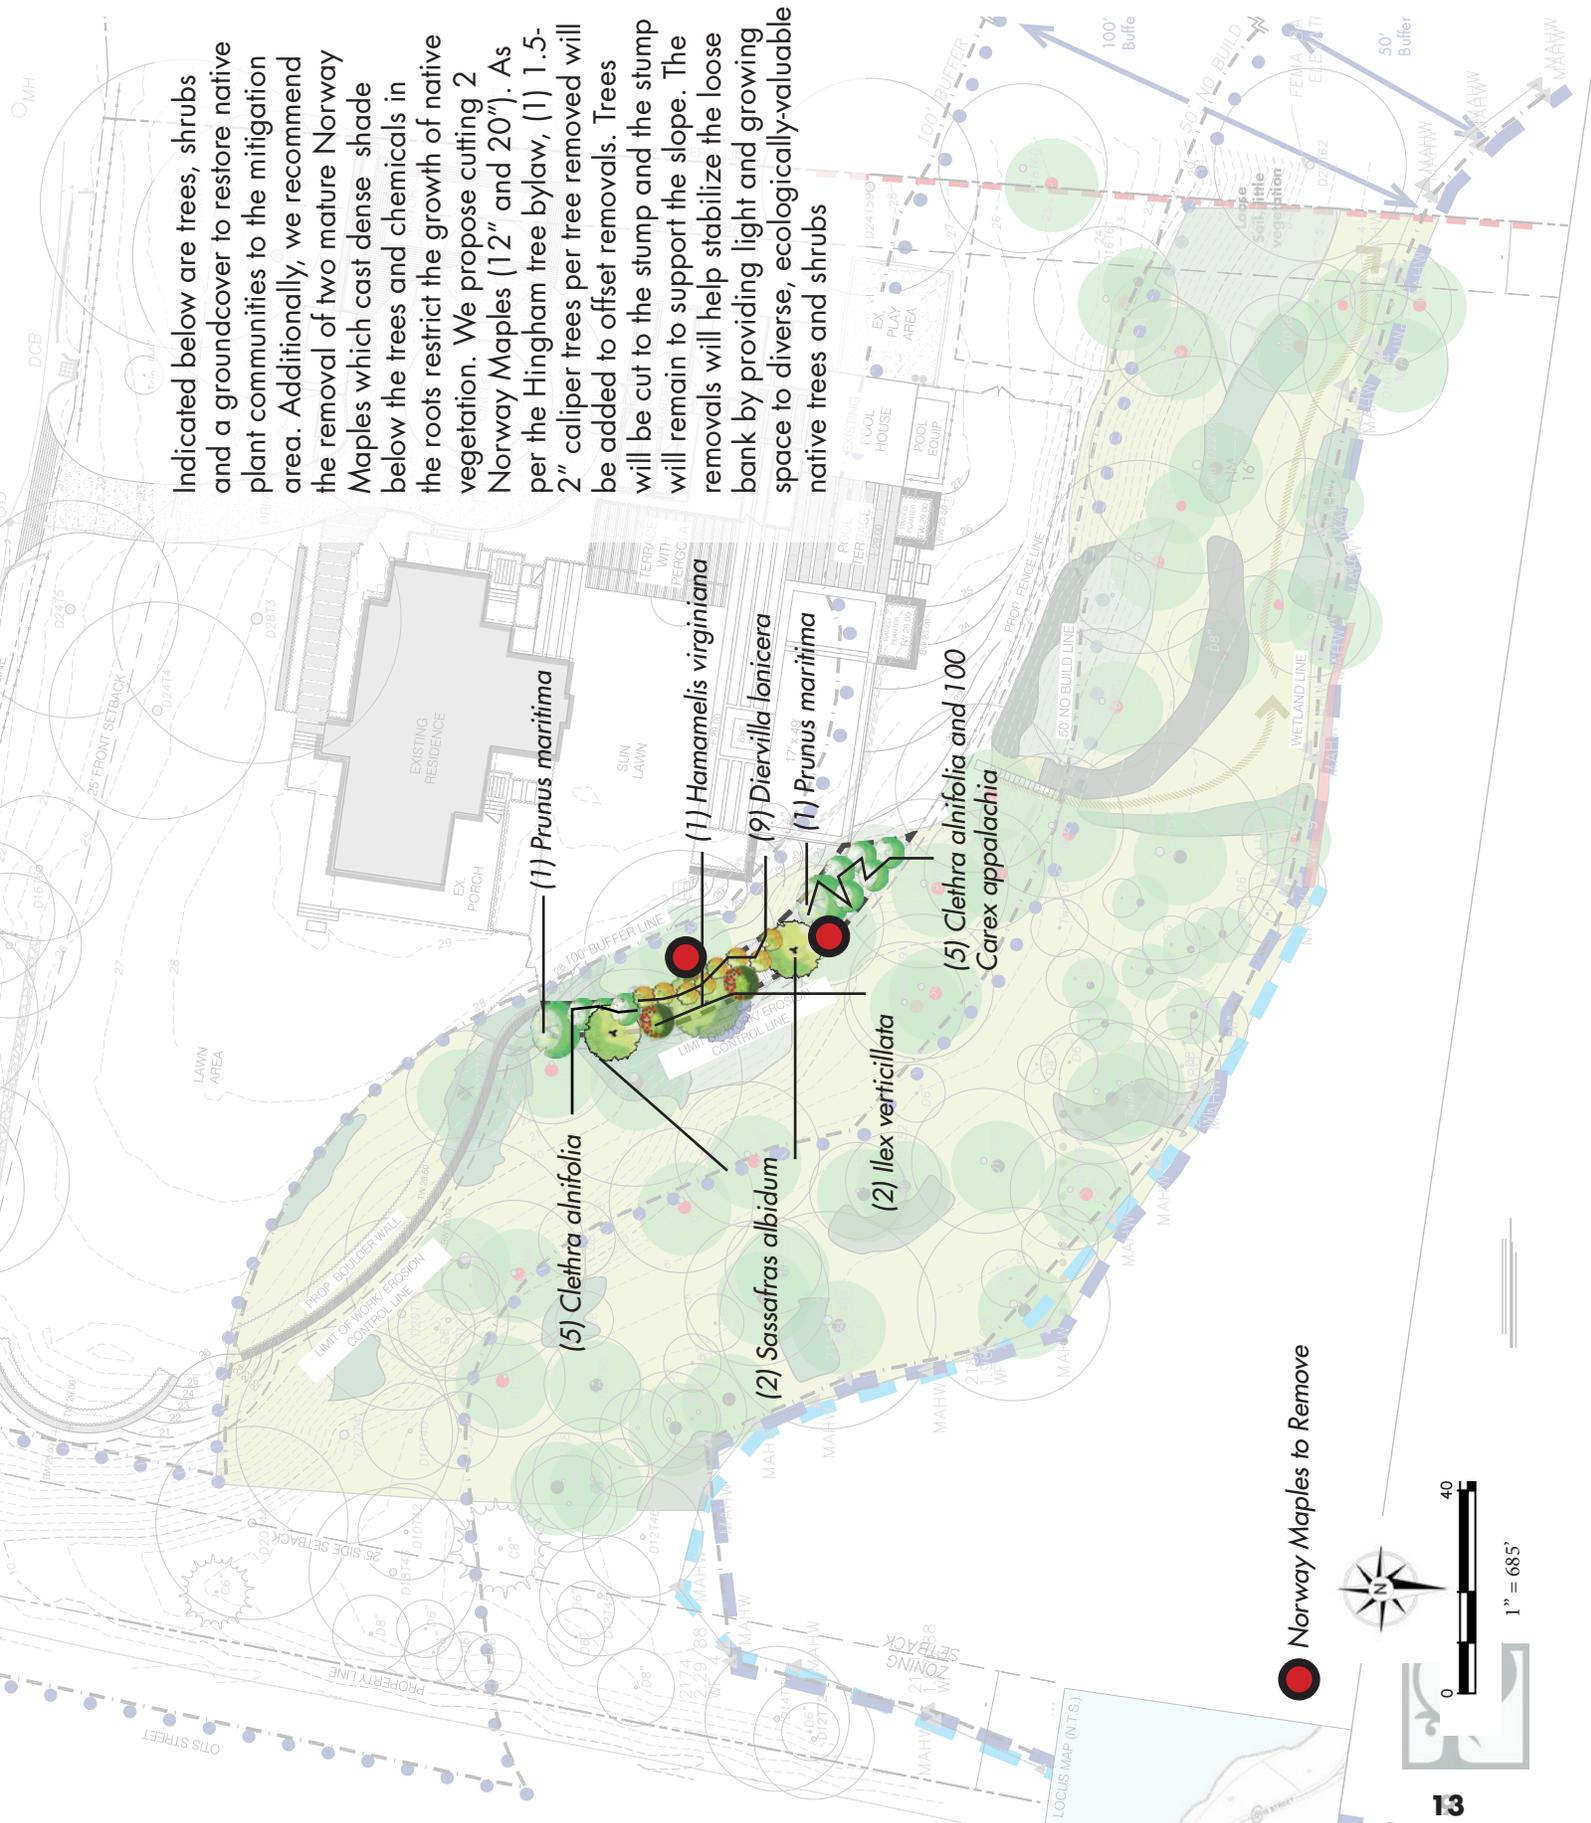
Indicated below are trees, shrubs and a groundcover to restore native plant communities to the mitigation area. Additionally, we recommend the removal of two mature Norway Maples which cast dense shade below the trees and chemicals in the roots restrict the growth of native vegetation. We propose cutting 2 Norway Maples (12" and 20"). As per the Hingham tree bylaw, (1) 1.5-2" caliper trees per tree removed will be added to offset removals. Trees will be cut to the stump and the stump will remain to support the slope. The removals will help stabilize the loose bank by providing light and growing space to diverse, ecologically-valuable native trees and shrubs

(1) *Prunus maritima*

(1) *Hamamelis virginiana*

(9) *Diervilla lonicera*

(5) *Clethra alnifolia* and 100
Carex appalachia

(5) *Clethra alnifolia*

(2) *Sassafras albidum*

(2) *Ilex verticillata*

● Norway Maples to Remove

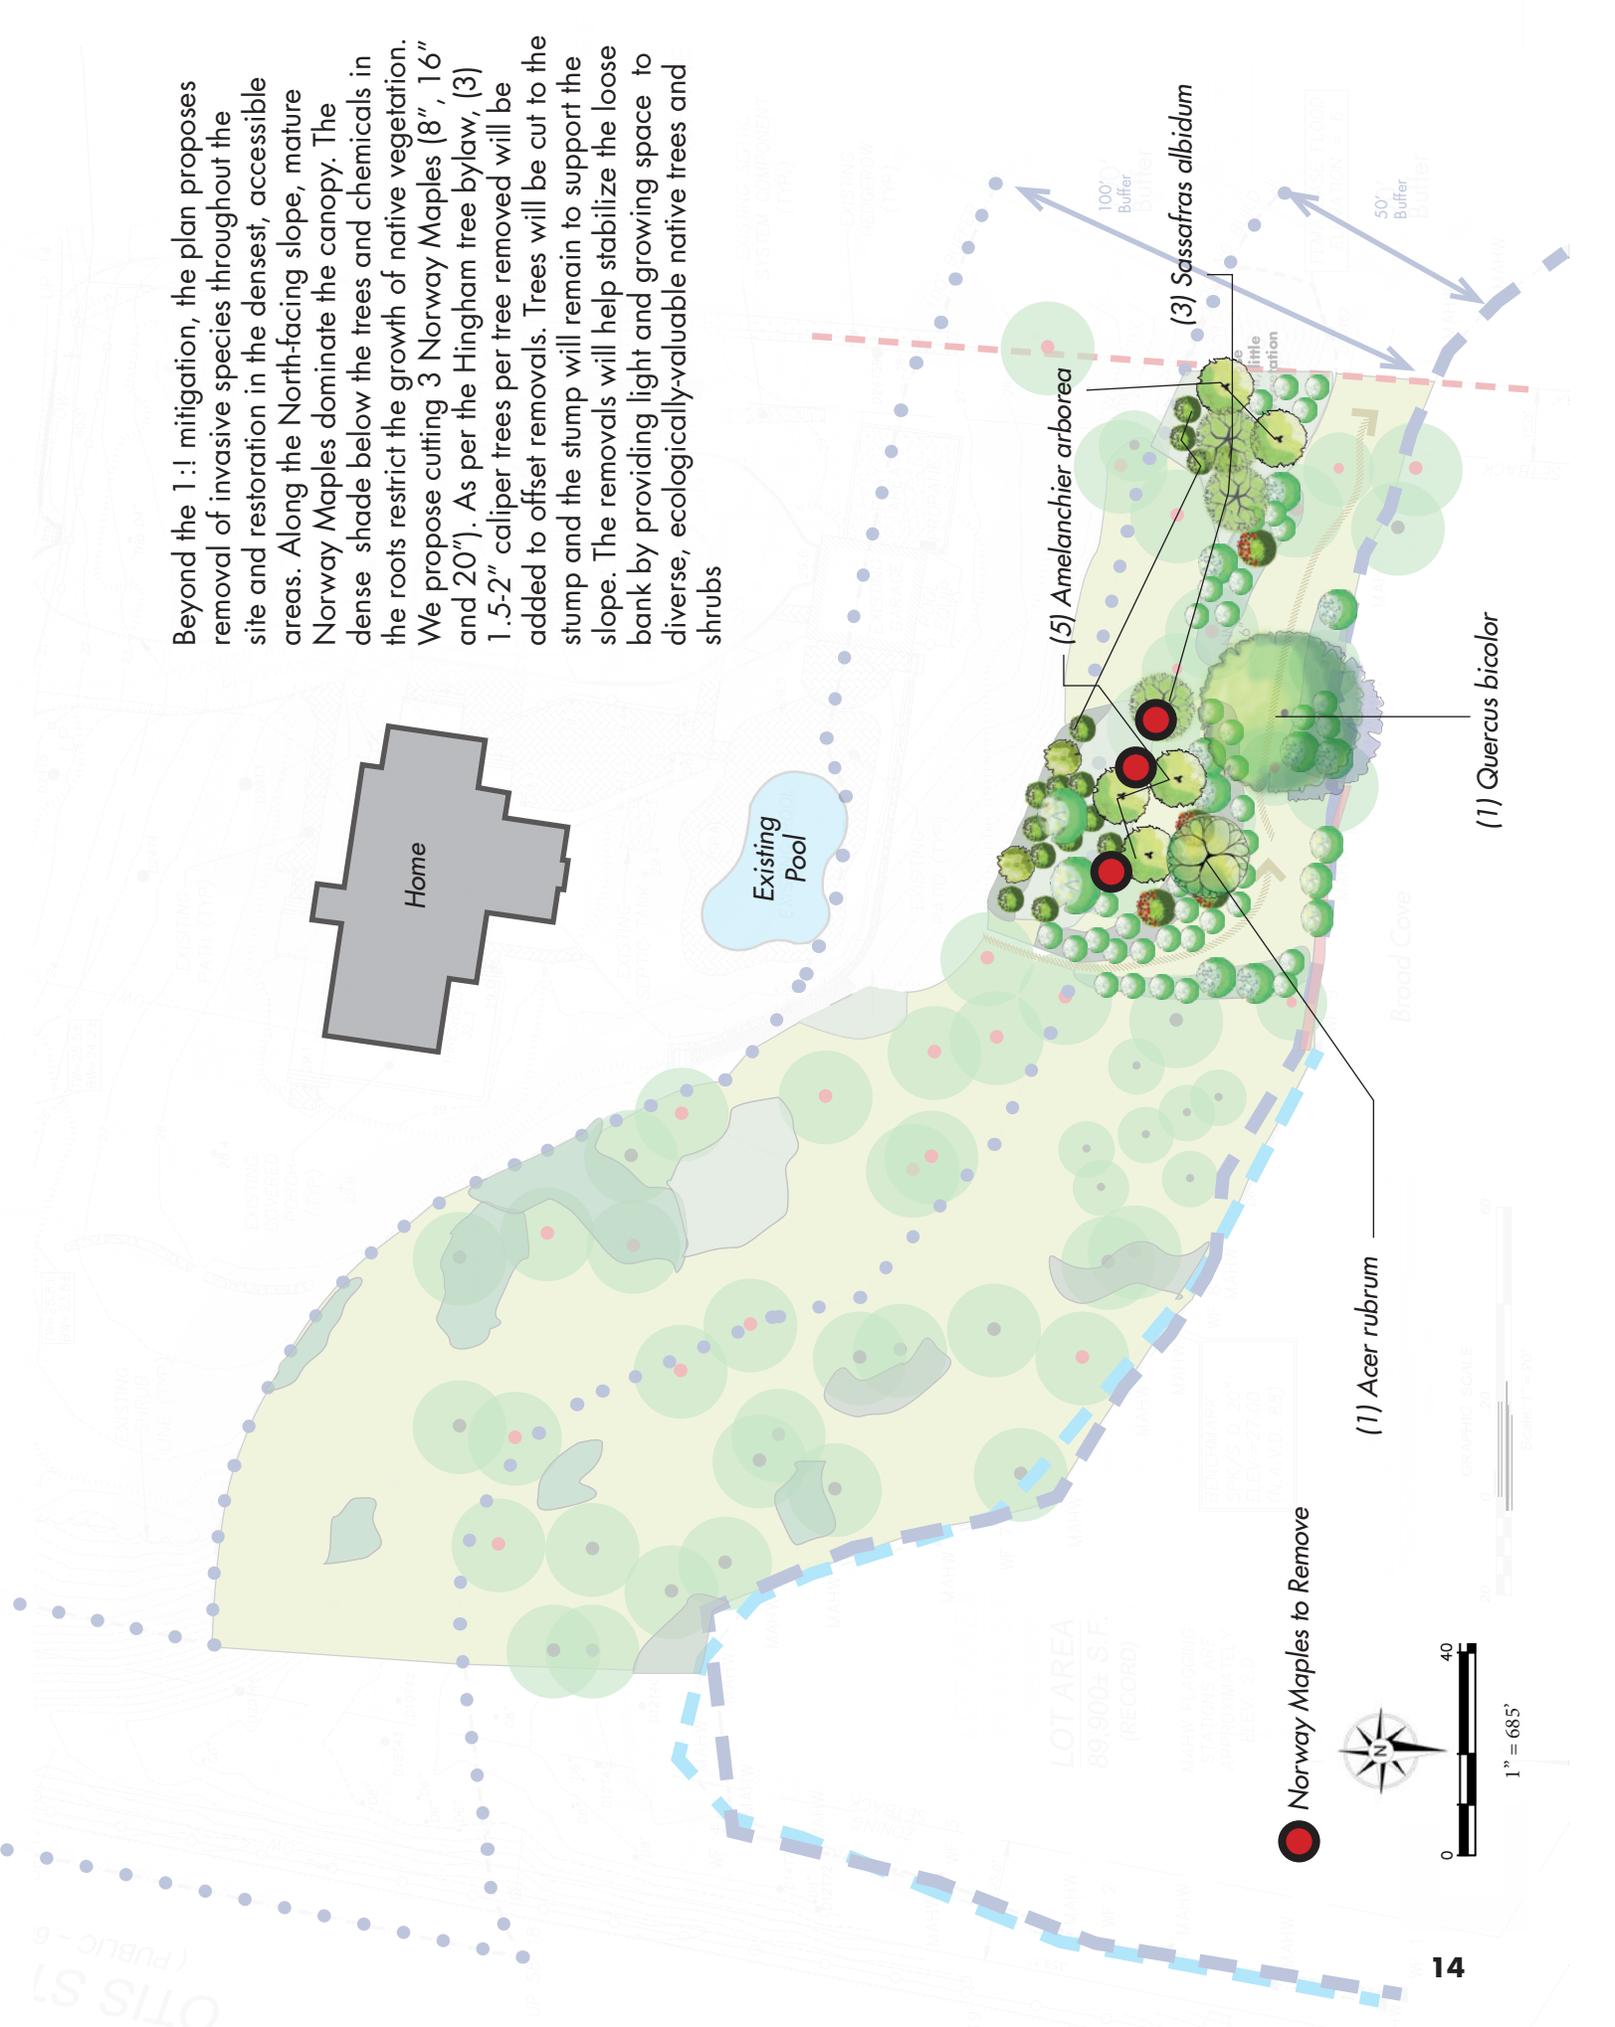
Beyond the 1:1 mitigation, the plan proposes removal of invasive species throughout the site and restoration in the densest, accessible areas. Along the North-facing slope, mature Norway Maples dominate the canopy. The dense shade below the trees and chemicals in the roots restrict the growth of native vegetation. We propose cutting 3 Norway Maples (8", 16" and 20"). As per the Hingham tree bylaw, (3) 1.5-2" caliper trees per tree removed will be added to offset removals. Trees will be cut to the stump and the stump will remain to support the slope. The removals will help stabilize the loose bank by providing light and growing space to diverse, ecologically-valuable native trees and shrubs
