Land Management Plan

A Narrative for Invasive Plant Management
and Native Plant Restoration

66 Burditt Ave
Hingham, MA

Summer 2020

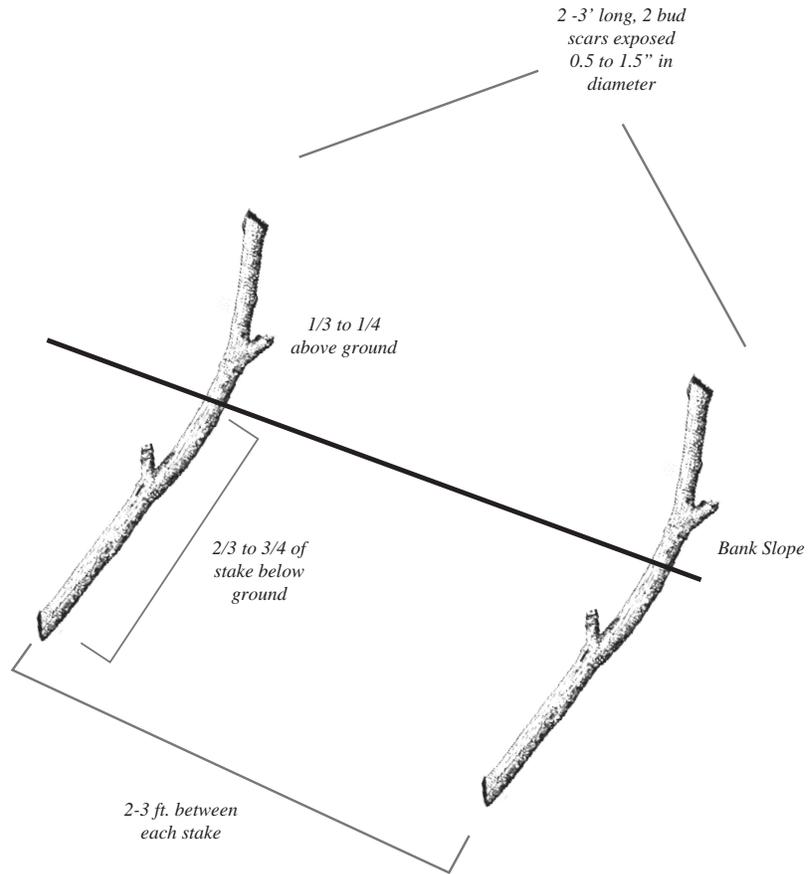
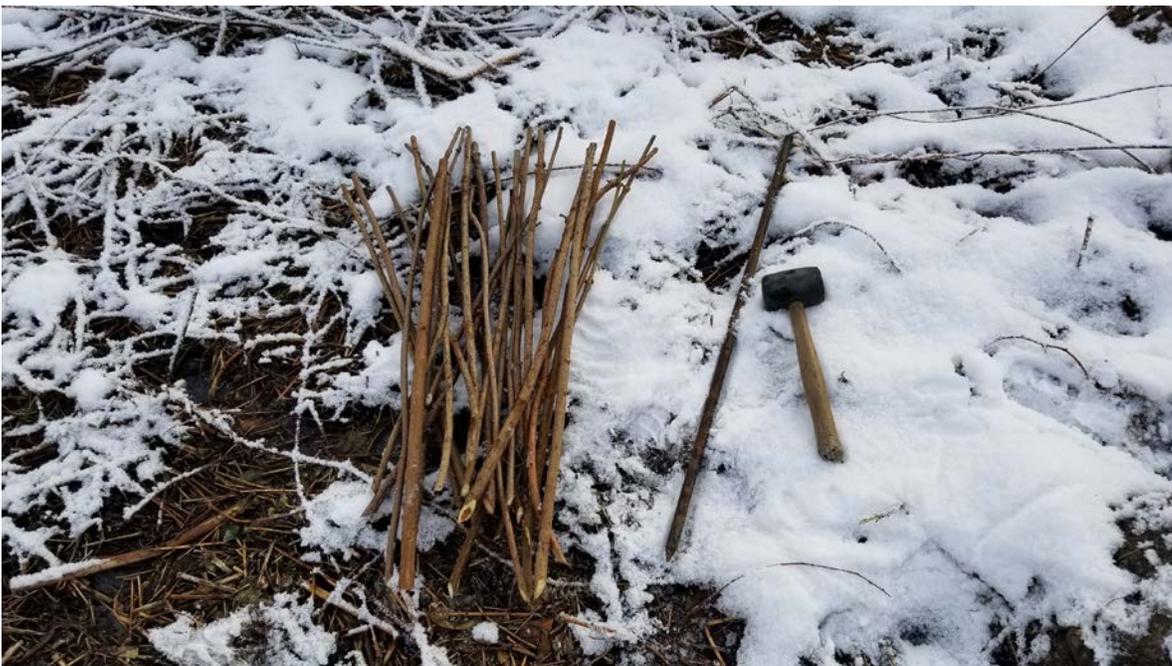
Live Stake Detail

Installing Live Stakes

- Live stakes are only installed successful while the twig is in dormancy. In New England, this window is generally between late October until the end of April the following year. They must be kept moist during and prior to installation.
- Stake rooting will be most effective if the stake is not positioned vertical but a little angled. Rebar or a pilot bar can be used to dig pilot holes to place live stakes in.
- Ensure at least half of the stake is below ground and 2 bud scars are exposed.
- Soil around the base of the stake must be tamped in for maximum stem-soil contact.
- If live stakes are planted in the fall, they should be covered with leaf mulch to protect from frost heaving. Leaf litter should be removed in early spring to prevent rot from occurring along the stems.
- For some species, root hormone can enhance establishment and can be added to the stem just before installing.

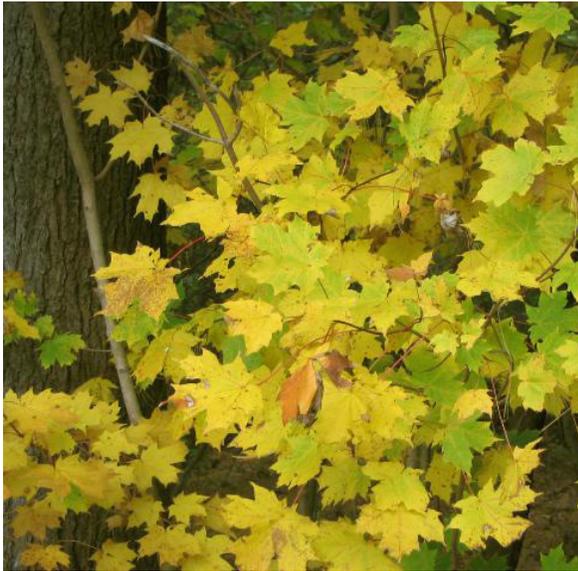
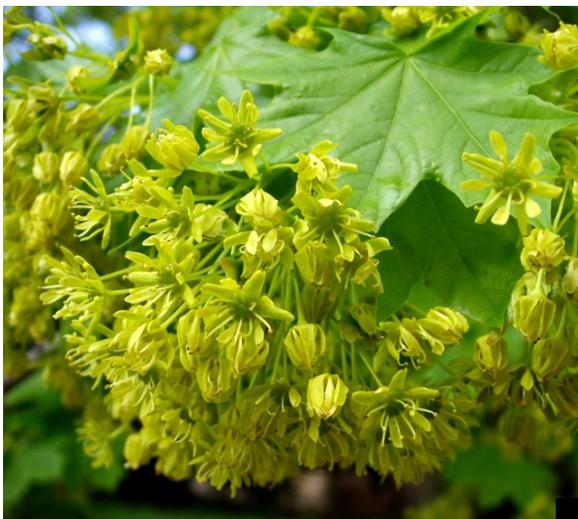
Acer platanoides,
Norway Maple

Norway maple is well adapted to various soils, grows in dry conditions, and can tolerate areas of soil pollution. Norway maples were widely planted in the United States as street trees and have escaped to natural habitats. Trees produce large numbers of seeds that are wind dispersed and invade natural areas, displacing native trees. Quickly establishing, they create a canopy of dense shade that prevents regeneration of native seedlings. Although thought to have allelopathic properties (meaning that the plant releases toxins that inhibit or prevent the growth of other plants), research has not been able to confirm this.

Manual methods of hand-pulling seedlings is recommended. For larger saplings, a 'Weed Wrench' is effective. Mature trees can be cut and the stump ground, or apply a Triclopyr based herbicide to the stump. Girdling the tree by cutting through the bark (cambium) layer all around the trunk is also an option. Girdling is most effective in spring and should include reducing the canopy for safety, but consider leaving trunks for habitat value.

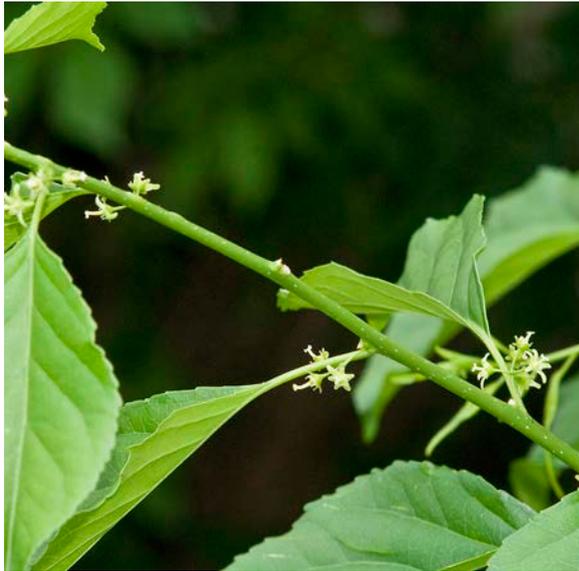
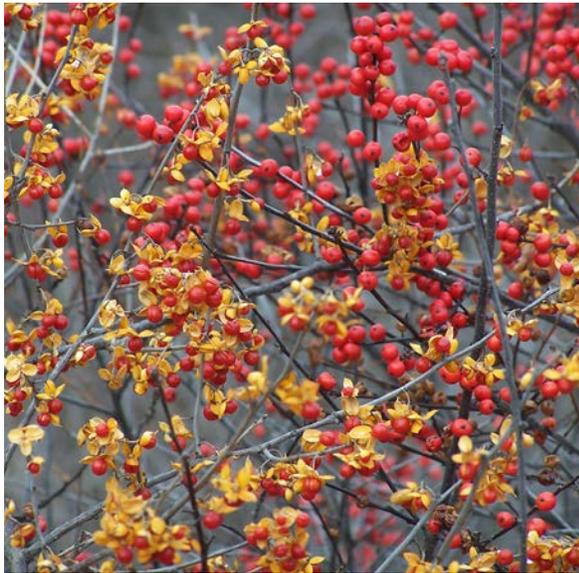
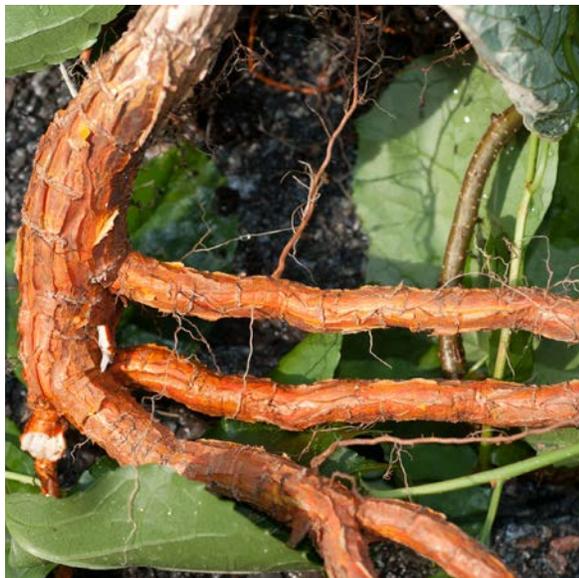
Celastrus orbiculatus, Asiatic Bittersweet is a deciduous climbing vine common in areas of disturbance in our New England forests. It has glossy, rounded leaves that are alternate with finely toothed margins. The leaves turn yellow in the fall. The fruiting plants produce small greenish flower clusters from leaf axils that mature in fall to produce high numbers of fruiting seed. The seed are noticeably yellow, globular capsules that split open at maturity to reveal red-orange fruiting seeds. Roots are also distinctly orange.

Bittersweet spreads easily into forest edges, woodlands, unmanaged meadows and old fields. Most disturbed sites that are not being actively managed that receive full sun are susceptible. The vine can tolerate shade but is often found in more open, sunny areas.

Asiatic Bittersweet management is a combination of manual hand pulling with cut & dab herbicide treatments. For established plants, vines should be cut to ground to reduce mass. Persistent root infestations will require repeat cutting and treatments over several seasons. Rake any seeds present, bagging in plastic bags, tying, and disposing of correctly.

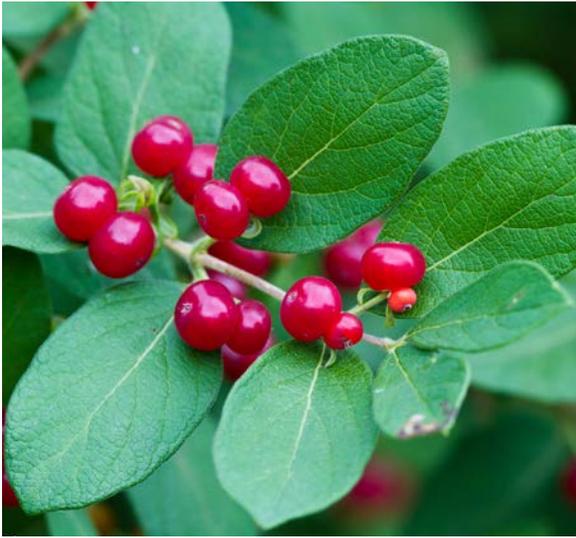
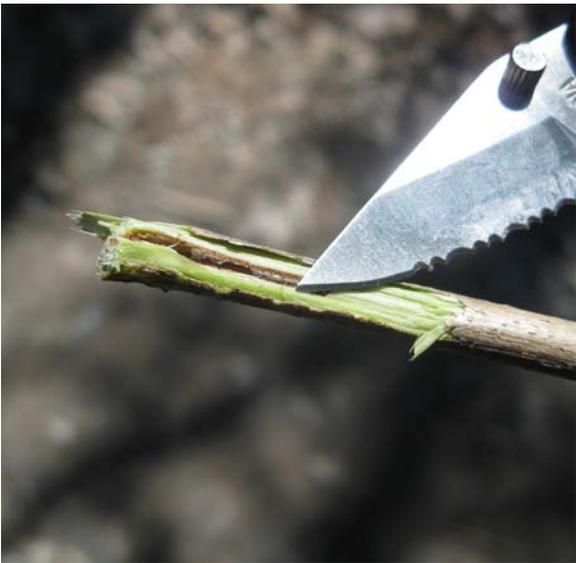
Lonicera morrowii,
Morrow's Honeysuckle

Lonicera morrowii, Morrow's honeysuckles are upright, deciduous shrubs that typically have a multi-stem mounding appearance. Oval leaves are opposite along the stem with smooth edges (no teeth or lobes) and hairy on the underside. Mature stems are often hollow on the interior and peeling on the outer bark. In the spring pairs of fragrant, tubular flowers less than an inch long are borne along the stem in the leaf axils. The fruits are red to orange, and fleshy .

Honeysuckles are relatively shade-intolerant and most often occur in forest edges, abandoned fields, and other open, upland habitats. Woodlands and open meadows, especially those that have been grazed or otherwise disturbed and are left unmanaged are also highly susceptible. Morrow's Honeysuckle have the greatest habitat diversity and are capable of invading wetland edges and other uncommon habitat types.

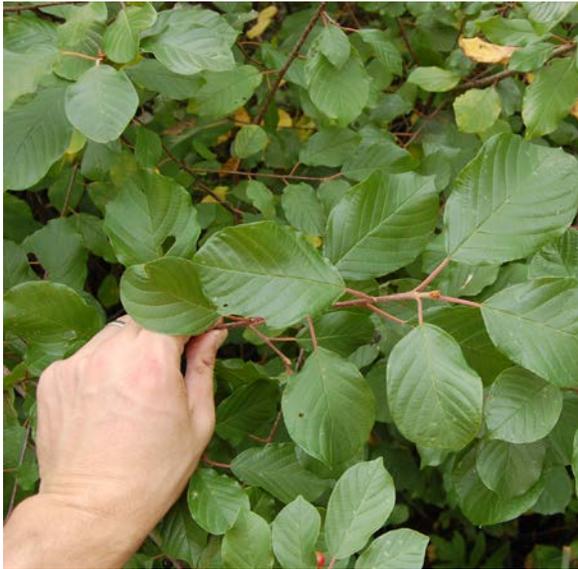
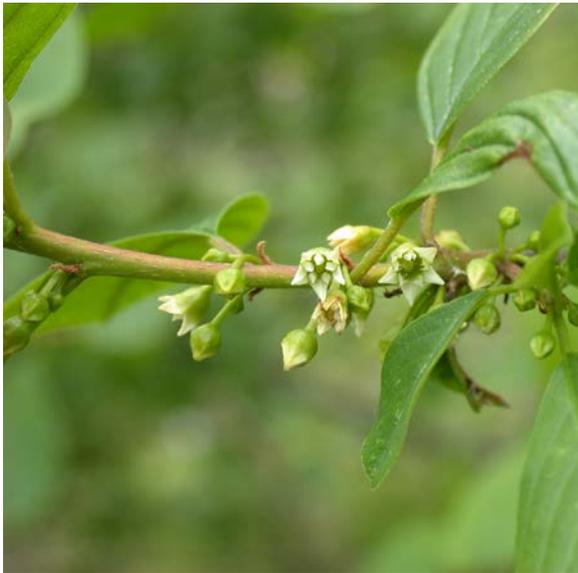
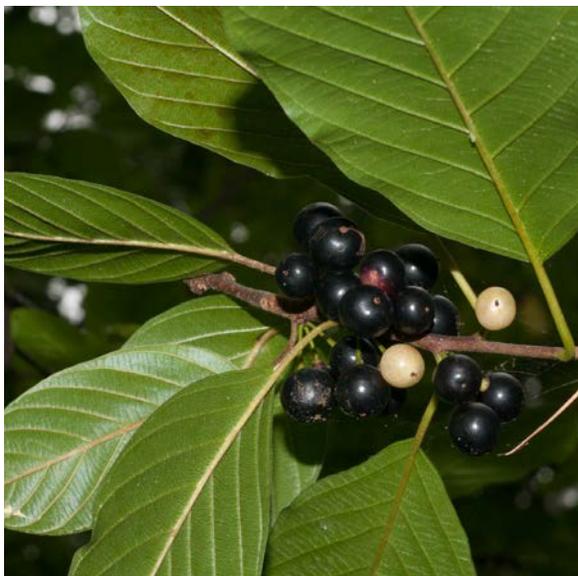
Frangula alnus,
Glossy buckthorn

Buckthorn thrives in early successional habitat. Abandoned agricultural or pasture lands, an opening in canopy within woodland, or unmanaged meadows are common areas. Buckthorn will also tolerate wetland soils where it can form dense stands that suppress the growth of native plant species. The seed is readily dispersed by birds, and the extended productivity of the fruit into winter allows the plant to be dispersed through the entire season.

Manual methods of hand-pulling seedlings is recommended. For larger saplings, a 'Weed Wrench' is effective. Mature Buckthorn can also be cut and the stump application of Triclopyr based herbicide. Rake any seeds present, bagging and disposing of correctly.

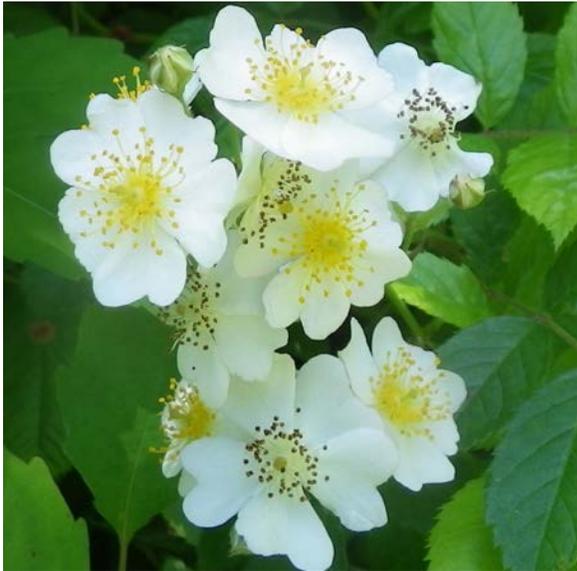
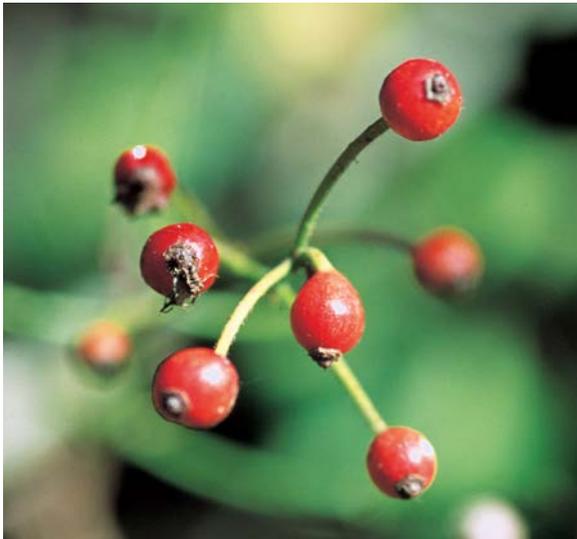
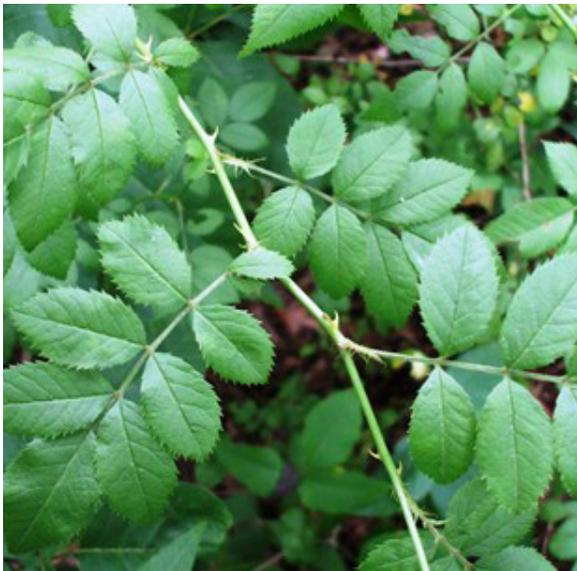
Rosa multiflora,
Multiflora rose

Rosa multiflora, Multiflora Rose is a shrub with arching canes with a mounding shape in the landscape. The leaves are divided into five to eleven sharply toothed leaflets. The base of each leaf stalk has a pair of fringed bracts which is a key identifier of the plant from other wild rose. Beginning in early summer, clusters of showy white flowers appear. The flowers are followed by developing red fruit, or hips, during the summer that remain on the plant through the winter.

Multiflora Rose thrives in early successional habitat. The rose has a wide tolerance for various soil, moisture, and light conditions. It occurs in dense woods, along river banks and roadsides and in open unmanaged fields. It can form a dense understory that suppresses growth of native plant species. The seed is readily dispersed by birds, and the extended productivity of the fruit into winter months allows wide spread distribution of the plant.

Manual methods of hand-pulling seedlings is effective. For more established shrubs, a combination of pruning to reduce mass followed by cut & dab treatments with a Triclopyr based herbicide is recommended. Persistent root infestations may require repeat cutting over several seasons. Rake any seeds present, bagging and disposing of correctly.

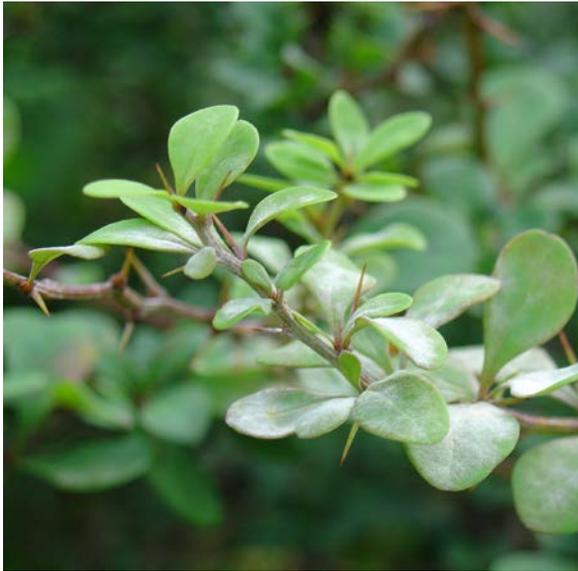
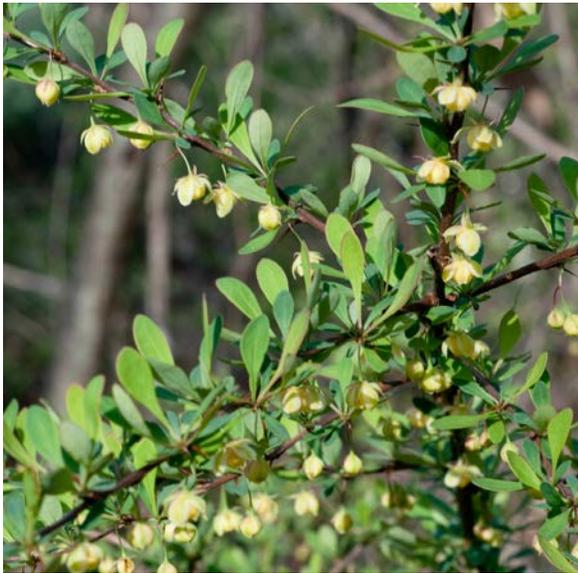
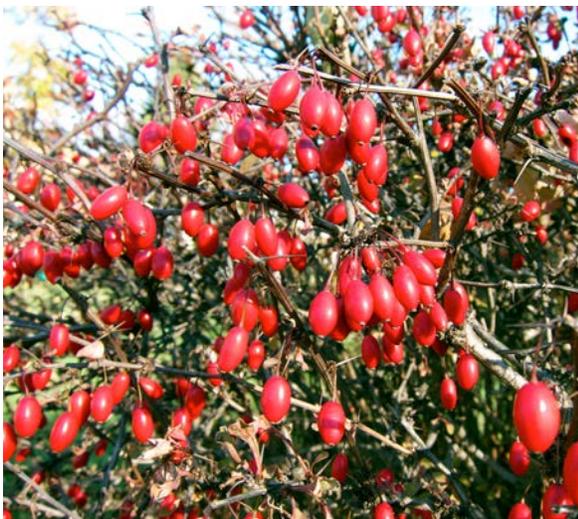
Japanese Barberry makes a dense, deciduous shrub understory that grows to 8 feet. Branches are brown, deeply grooved, zig-zag in form and bear a single sharp spine at each node. The leaves are small ($\frac{1}{2}$ to $1\frac{1}{2}$ inches long), oval shaped, green, bluish-green, or dark reddish purple. Flowering occurs from mid-April to May in the northeast. Pale yellow flowers about $\frac{1}{4}$ in. Across hang in umbrella-shaped clusters of 2-4 flowers along the length of the stem. The fruits are bright red berries about $\frac{1}{3}$ " long that are borne on narrow stalks. They mature during late summer and fall and

Japanese Barberry is shade tolerant, drought resistant, and adaptable to a variety of open and forested habitats, and disturbed areas. It prefers to grow in full sun, but will flower and fruit even in heavy shade. There is also strong research to support the surprise benefit of controlling Japanese Barberry in the reduction of black legged (or deer) tick populations.

Japanese Barberry is a prolific seed-producer with a high germination rate, so prevention of seed production should be a management priority. Barberry also spreads by rhizome, so underground root fragments should be removed. Manual methods of hand pulling sprouts works well in small populations, but large populations may require chemical applications by applying a 2% solution of glyphosate

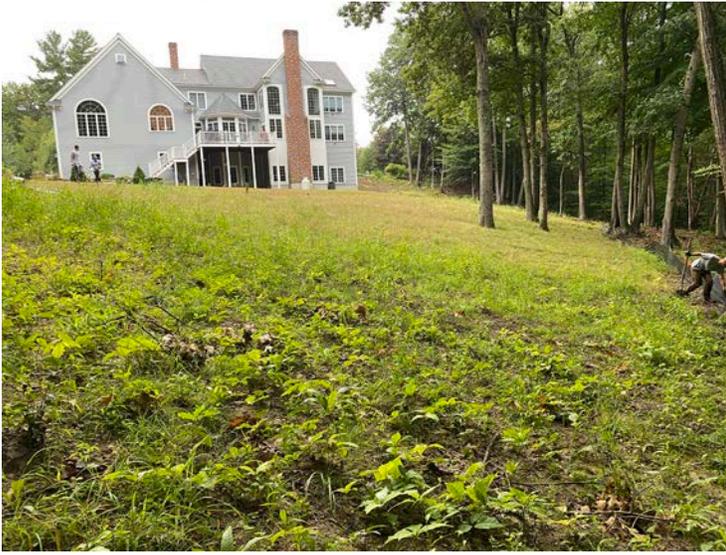
1. Existing Conditions - Client under an enforcement order to restore buffer after tree & shrub removal and hydroseeding turf

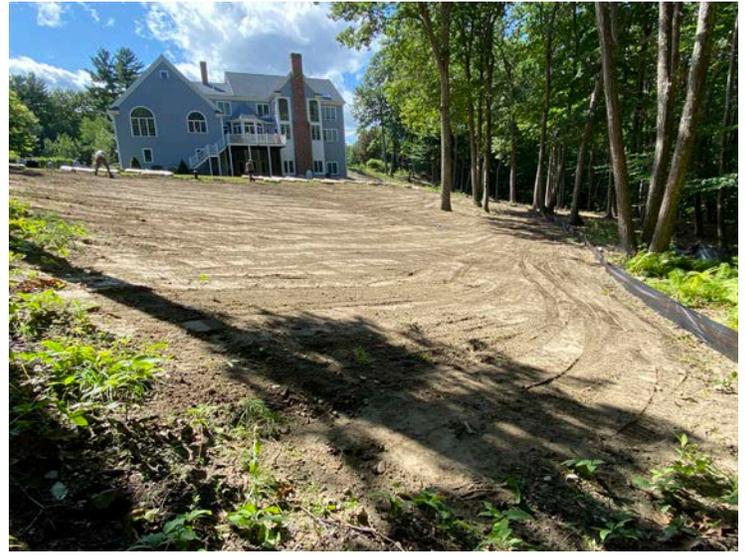
2. After installation of sediment control, we mechanically mowed area and seeded with New England Conservation and Wildlife Seed Mix

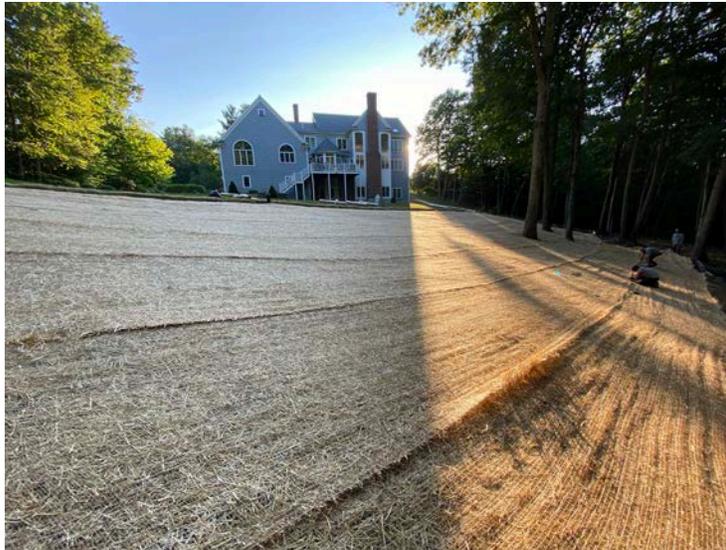
3. Covered exposed loam with straw erosion control blanket: BioNet S75BN and staple into existing slope

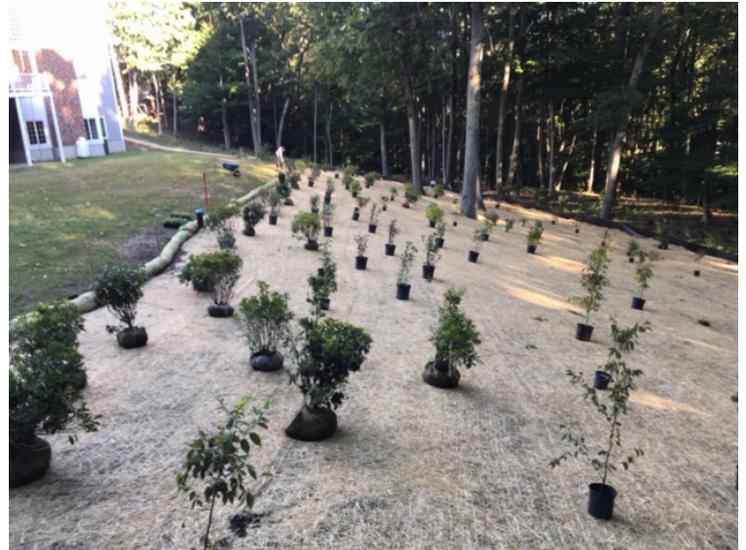
4. Layout native plant species suitable for an Oak Hickory Forest plant community

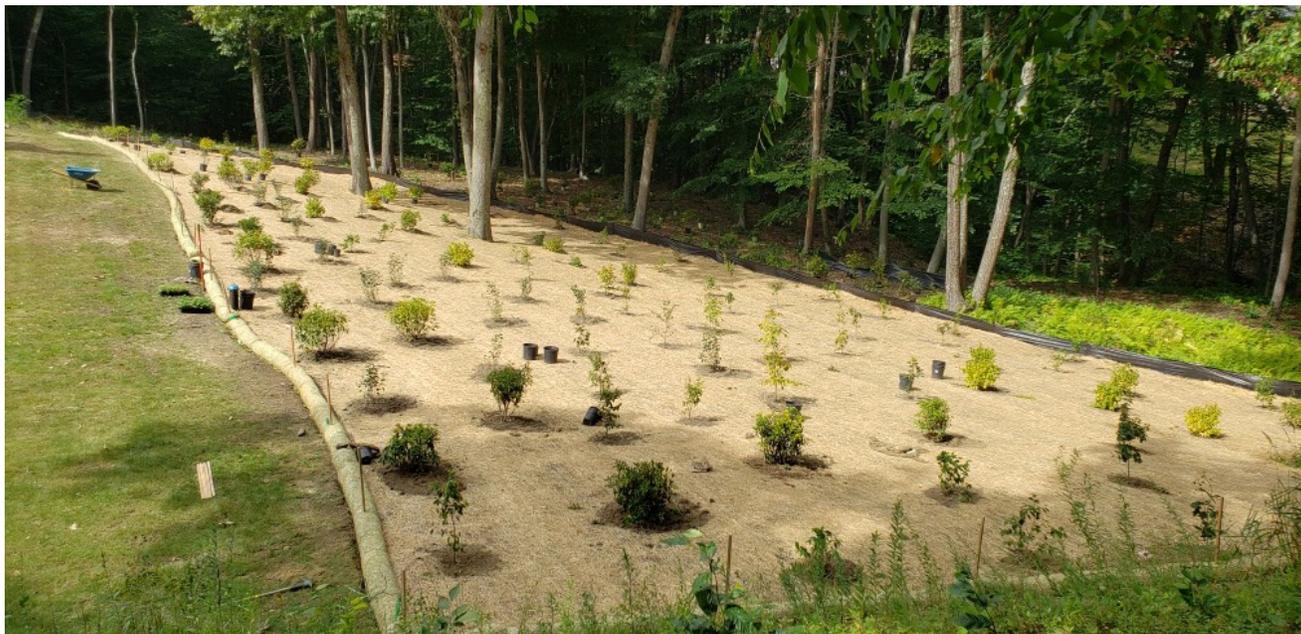
5. Native plant species installed: *Quercus rubra*, *Kalmia latifolia*, *Ostrya virginiana*, *Corylus americana*, *Betula lenta*, *Fagus grandiflora* and *Viburnum acerfolium*
